# **Tsunami Survey at Kanyakumari**

**Report on field survey at Kanyakumari**

**December 2007**

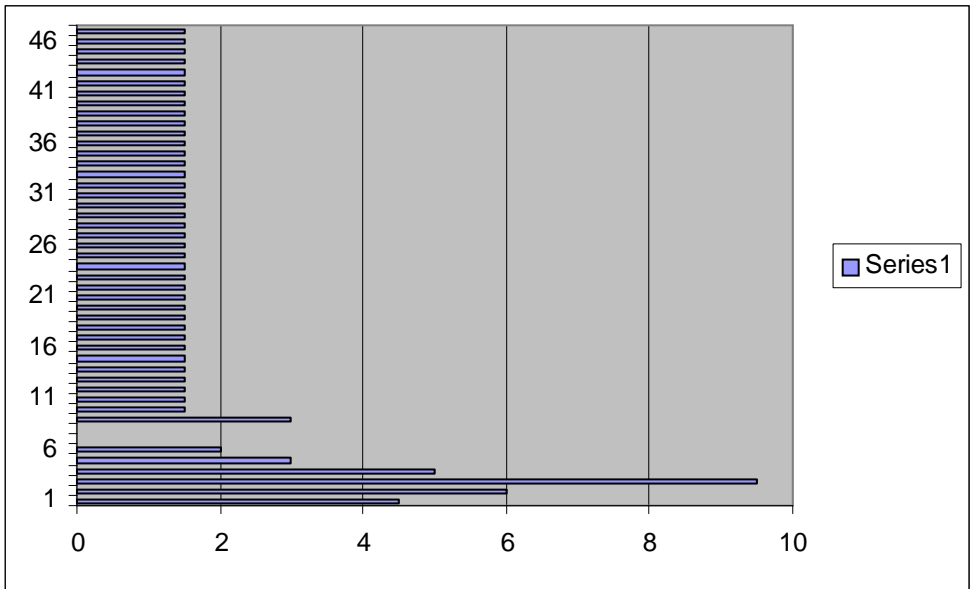
Graph 1. The height of Tsunami at different locations. Observation Points on Vertical axis and Tsunami height (m) on horizontal axes.

- (a) The tsunami height at majority of the points along the Kanyakumari was about 1.8 m
- (b) At locations 1 to 9 the heights were in the range 3 to 9.5 m

- (c) The Kanyakumari shoreline appears to have experienced tsunami up to 1.5 m. The Vivekananda Rock Memorial and the Thiruvalluvar Statue might have given some partial protection. The tsunami waves hit these two locations first and then arrived at Kanyakumari shoreline.

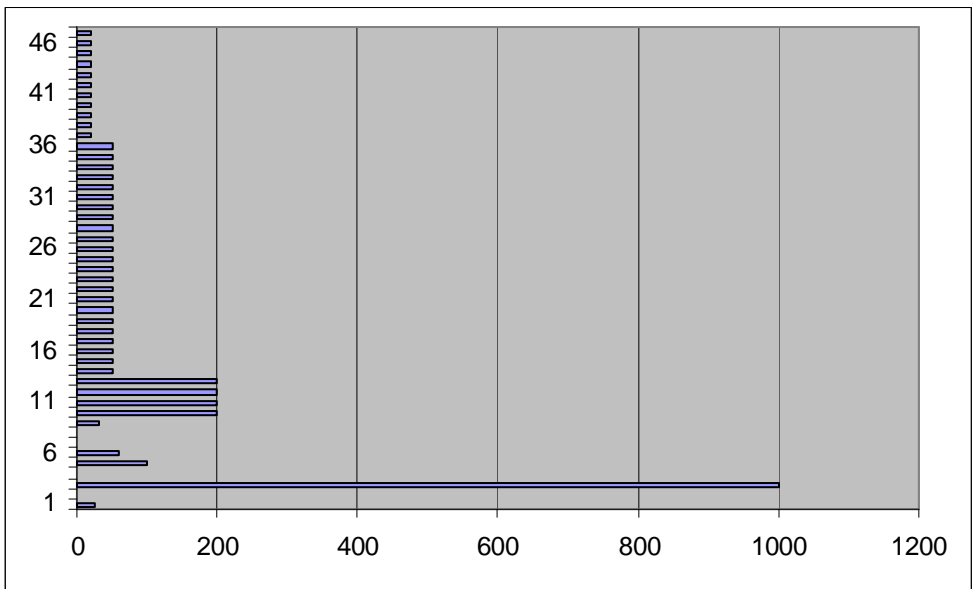
Graph 2. Inundation at different points. Observations Points on vertical axis, inundation (m) on horizontal axis.

- (d) The inundation varies from 50 m to 1000 m. It was about 200 m at locations 14 to 36 and about 50 m at points 37 to 46. At some locations where tsunami height was up to 1.5 m and inundation was just 200 m a number of fishermen are staying and large number of fishing boats are anchored at this location. At these and similar locations where extensive inundations have been observed it is recommended that Gabions may be placed. The Gabions are discussed in Appendix – II. These are wire cages filled with stones of about 25 to 30 kg weight. The Gabions provide useful protection.

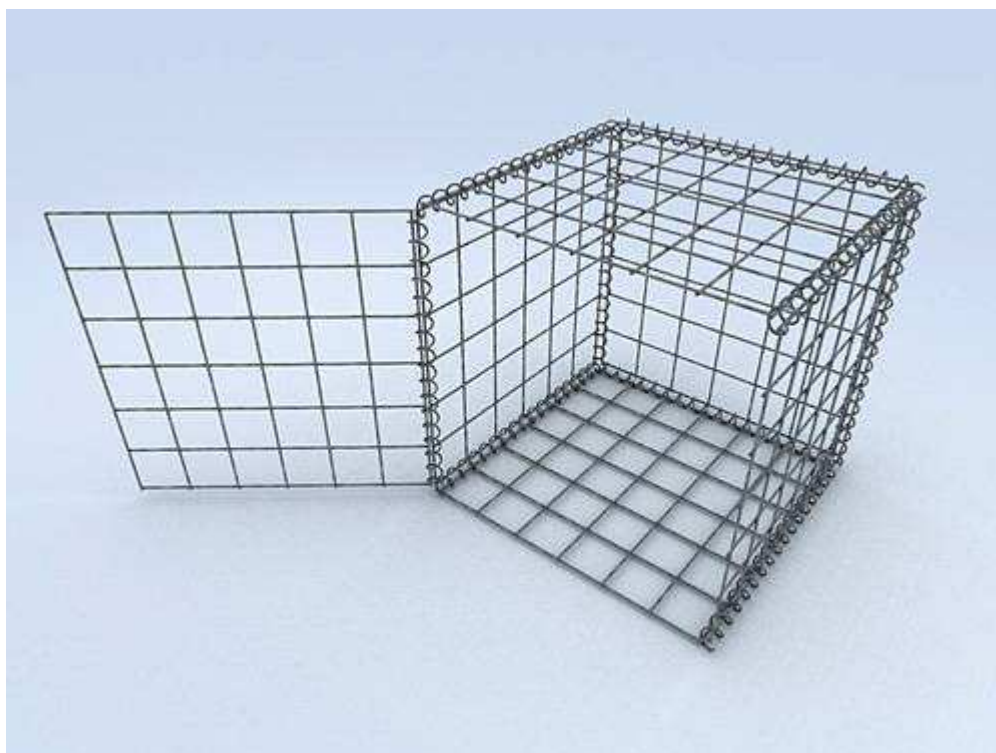
Gabions provide a simple bank protection technique. This consists of a nylon wire cage usually of 1 x 1 x 1 cu.m size. This cage is shown in Fig. G1 below:

Fig. G1: The wire Cage of Gabion

The nylon rope diameter is usually between 8 to 12 mm sizes. The size depends upon the tidal force and tidal range. The difference between high tide and low tide is known as 'Tidal Range'. At Kanyakumari the Tidal Range is 0.6 meters. Considering these factors, about 10 mm nylon ropes may be suitable. This cage is prepared and placed at the site of installation. This cage is then filled with stones of weight between 25 to 30 kg. After the cage is filled with stones the lid side is sewed and the Gabion is placed at the shore protection area. If required and depending up on the geometry of the shoreline, the Gabion size could be 2 m (length) x 1 m (height) x 1 m (width). During course of time and due to the tidal action the voids in the Gabion are filled by sand and then the cage becomes a firmly consolidated part of the shore. When Tsunami hits the Gabion it

**Recommendation: At suitable locations along the Kanyakumari coast the use Gabions would be useful in mitigating the Tsunami disaster.**

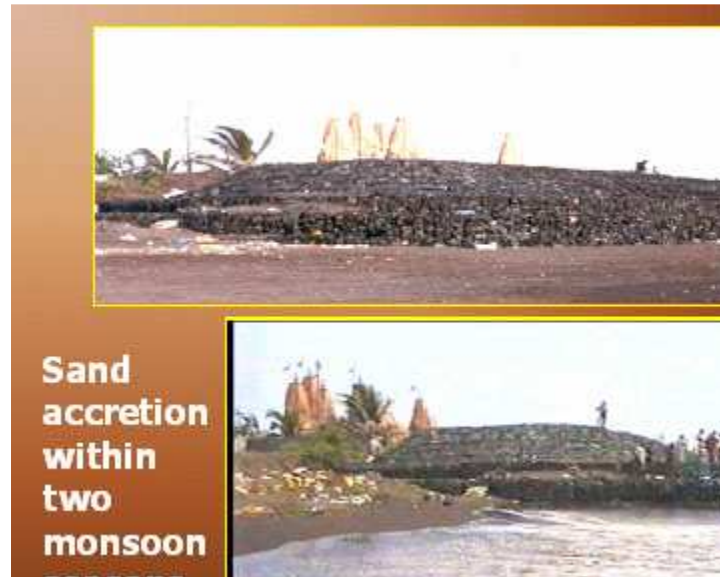
An example from Teethal, District Valsad in Gujarat would illustrate the use of Gabions. This temple on the shore of Teethal was facing the problem of coastal erosion and the temple was threatened due to this. Suitable placing of Gabions near the Temple has provided very useful protective measures. After some time grass and other vegetation grows on the consolidated Gabions and the tsunami measures are fortified. The temple and the Gabions are shown in Fig. G 2

Fig. G 2 Gabions at Teethal Temple in Valsad District, Gujarat. Upper photo shows the general view of the Gabions and the lower photo shows the Temple and the Gabions at site.

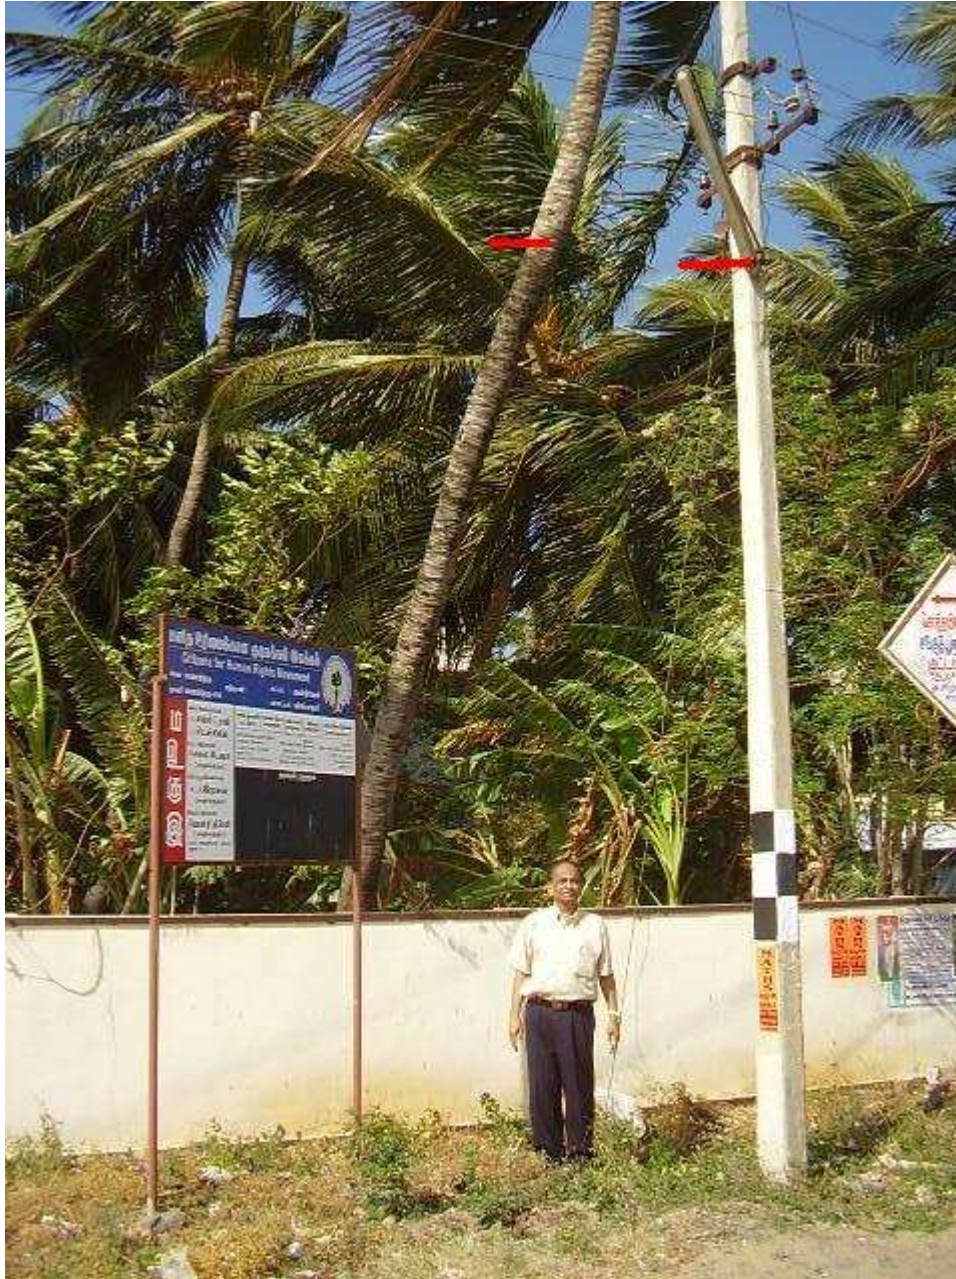
- (f) Useful field observation: While surveying the team has observed a young coconut tree. The colour and mark on the trunk of tree show the mark of tsunami. This is shown in Photo 1.

- (e) The tsunami height is corroborated by the corrosion of the electrical fittings on the nearby lamppost.
- (f) The spiral staircase of the sun set view tower in that location was washed away and the water level was up to the bottom brim of the flooring. It is understood a person was on the top of the tower jumped in to the water. His body could not be retrieved.

Photo 1. Shows the tsunami mark on the coconut tree and metallic part on the electric lamppost, which have been corroded. The points have been marked in red. This gives a clear idea of Tsunami height.

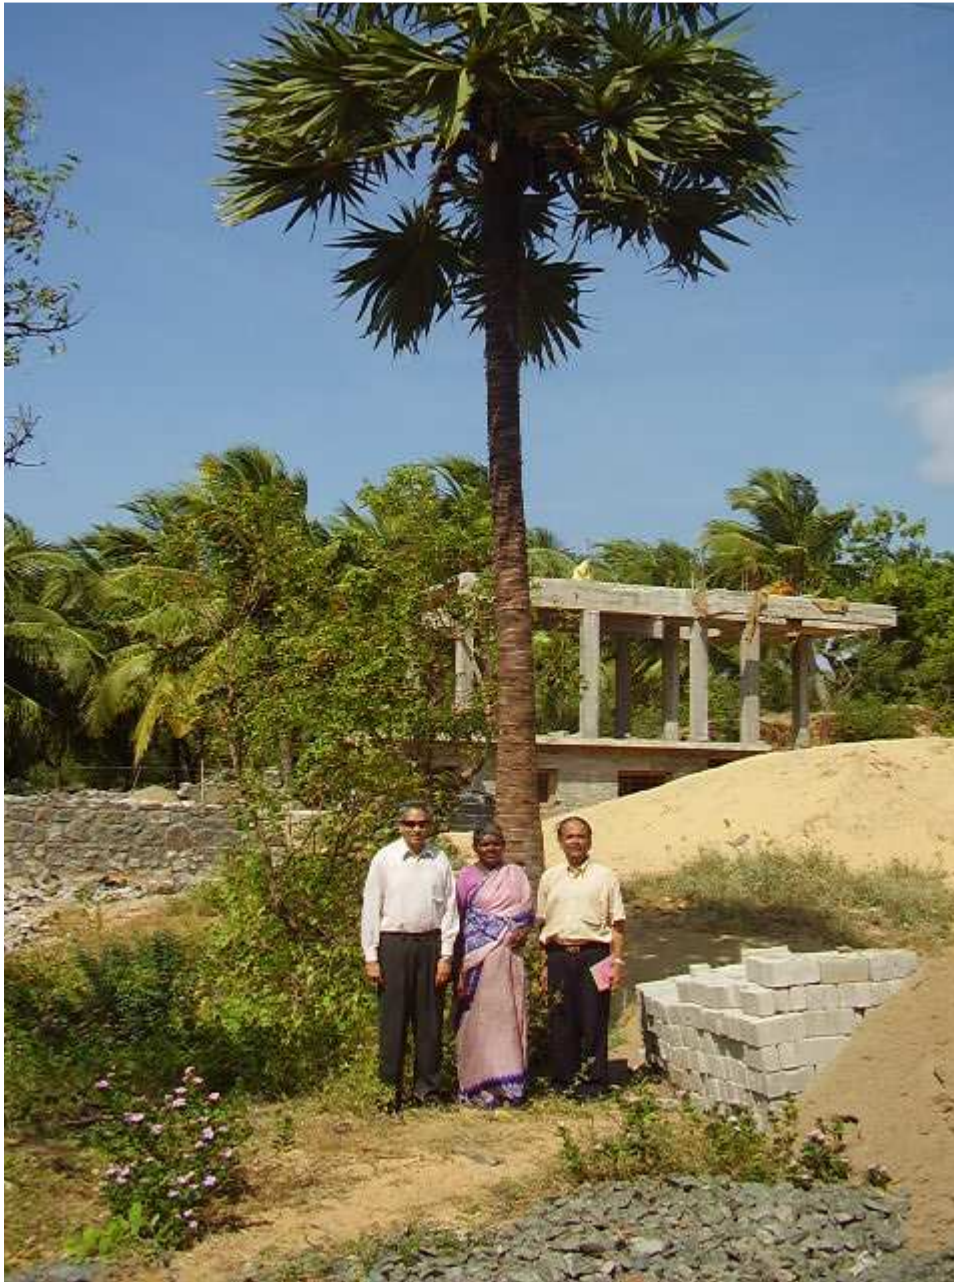
A middle age lady Mrs. Muttama Palmani age about 50 years, was hit by Tsunami and she got stuck up on a tree. Her nephew Selvaraj was also washed away and got stuck up at another tree. See Photo no. 2 and 3. This observation was useful in arriving at the height of tsunami.
- (g) A church shown in Photo 4 has been repaired and this also shows the height of tsunami at that location.
- (h) In addition to the placing of Gabions, suitable pre-tsunami warning mechanism may be worked out. In addition to the announcements on radio and television, it would be most effective if the tsunami warning were sent by SMS. At present it is possible to send SMS by one operation to about 3000 to 5000 Cell phone users. Suitable mechanism may be worked out with Cell companies.

- (c) At 1120 hrs huge water wave hit. She was lifted, her head hit a lamppost and she lost her tooth. She became unconscious and was stuck up at a top of a palm tree situated about 10 m from her shop. Her sister's son Silvaraj age about 30 yrs. was also washed away and stuck up at a cocconut tree located at about 25-30 m from the shop. Her husband was in bathroom and could not move out and had suffered injuries. Both of them were in hospital for 42 days (wife) and 45 days (husband).

- (d) After about 20 minutes the water level came down. Selvaraj shouted for help, people came and rescued both of them. The heights of the both the tree are positively indicative of the tsunami height of about 7-8 m (plus ground to sea level of 2 m)

Photo 2. The lady in the picture Muttama was stuck up at the top of this tree during tsunami. On left is Tad Murty and on Right is Arun Bapat

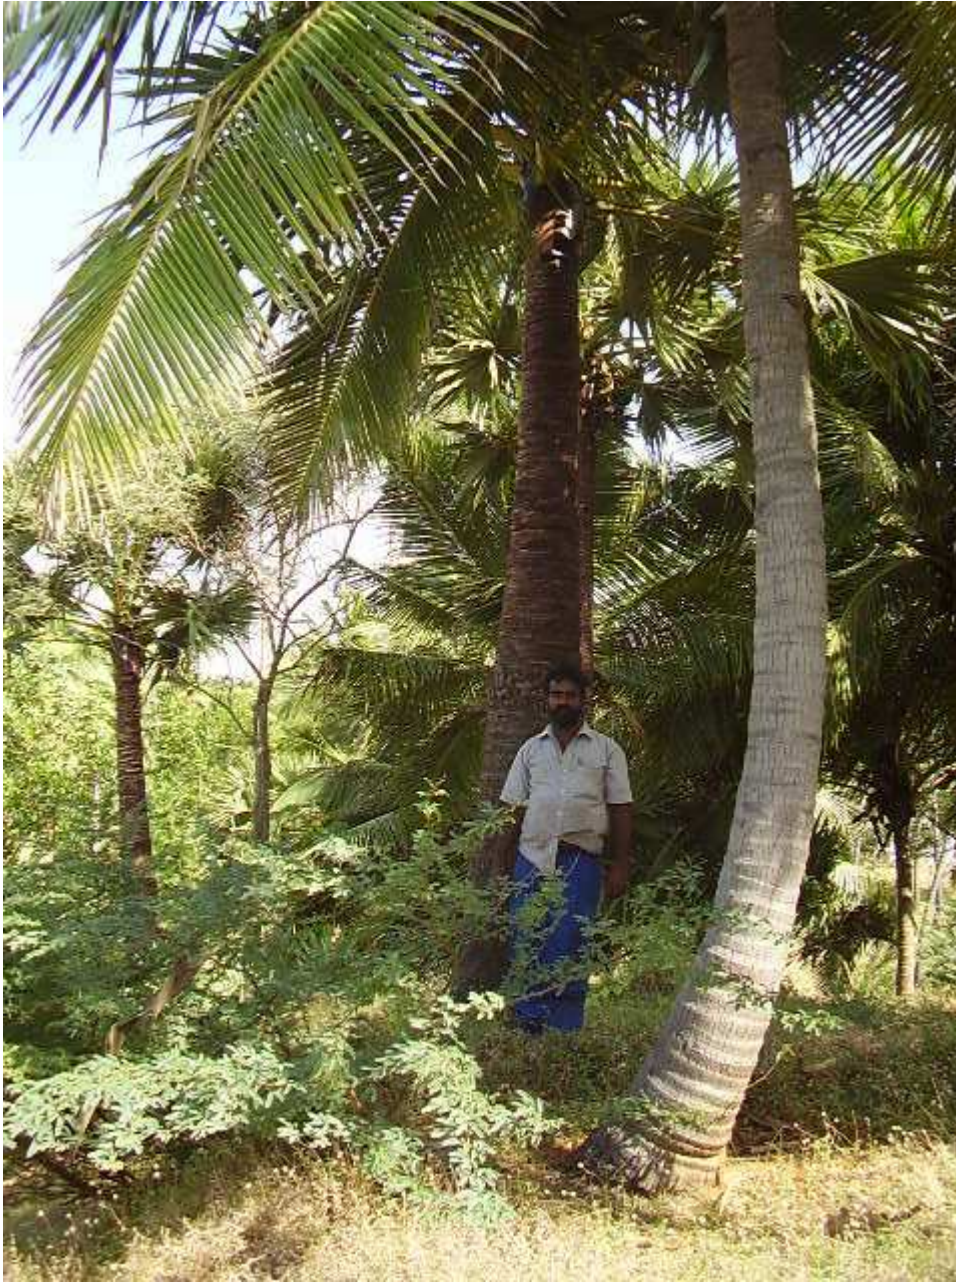
Photo 3. Selvaraj was stuck up at the tree where he is standing.

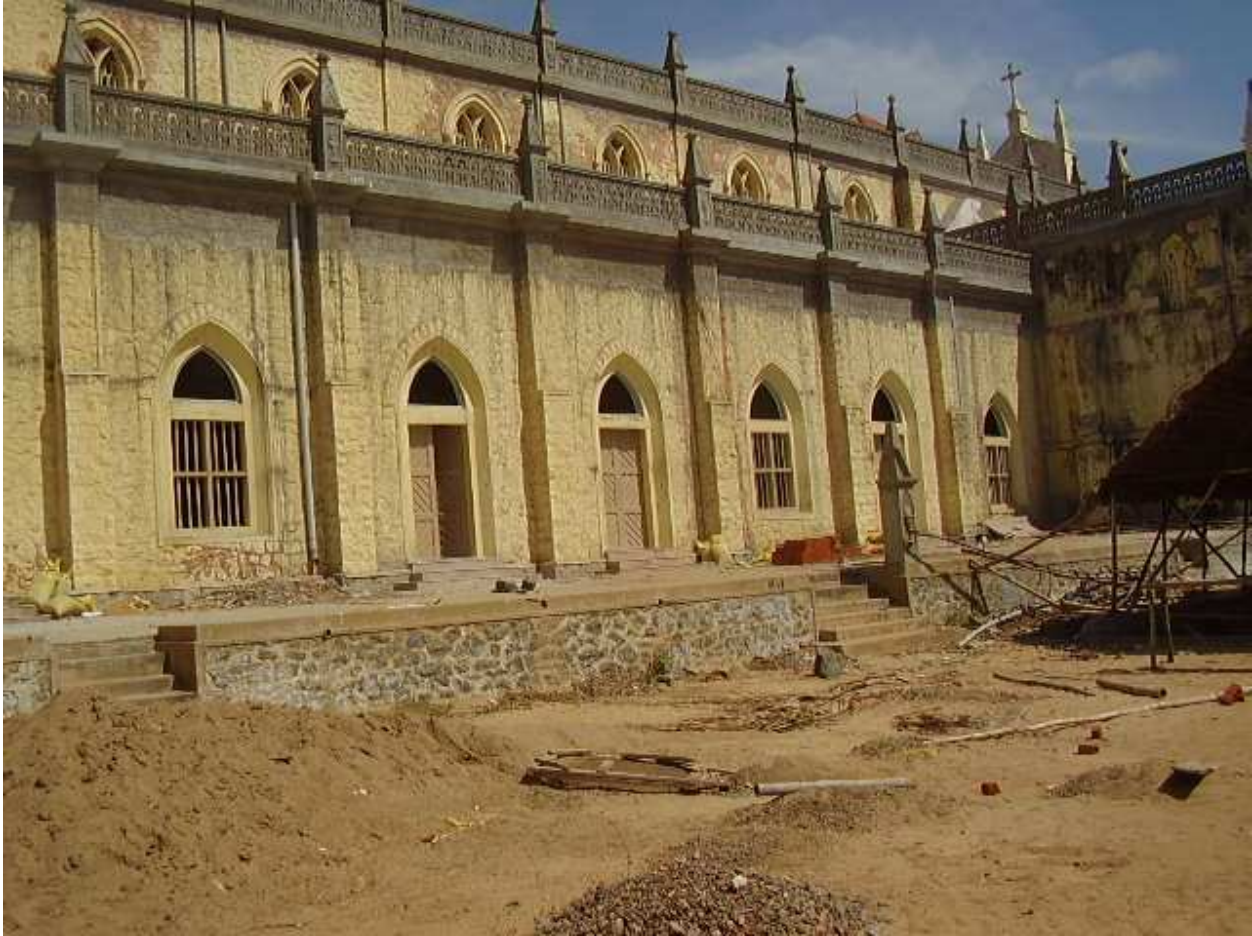
- (g) In the Manakkudi village enroute to the Beach a Church located at about 2m above sea level has undergone repair about 6 m from ground through out the sea side wall.

Photo 4. The repairs on first floor indicate damage during tsunami and the level of Tsunami height.
